Grading Capacitor Requirements

For Metal-Enclosed Capacitor Banks Utilizing Vacuum Switches with Two or More Series Connected Vacuum Bottles

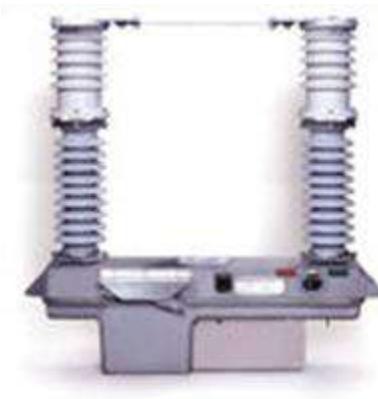
Figure 1 - Typical 34.5 kV Vacuum Switch With Two Series Connected Vacuum Bottles.

Metal-Enclosed Capacitor Banks and Harmonic Filter Banks applied at the 34.5kV to 38kV voltage level often utilize vacuum switches (as shown in Figure 1) equipped with two or more series connected vacuum interrupters. These vacuum switches, when applied within a metal enclosure, are more likely to re-strike and result in equipment damage. To reduce this possibility, NEPSI recommends a grading capacitor be connected across each of the series connected vacuum interrupters.

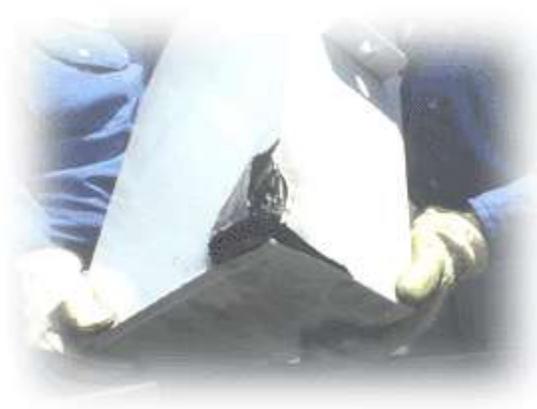
Figure two shows a typical case rupture caused by vacuum switch re-strike. In this particular restrike case, five capacitors cans ruptured as shown.

Vacuum switches that utilize two or more series connected vacuum bottles work on the premise that each vacuum bottle will share nearly equal percentages of the transient recovery voltage during interruption. The application of this premise allows vacuum switch manufacturers to use lower voltage rated vacuum bottles to achieve load current interruption at higher voltage levels. When the transient recovery voltage is not equally shared, however, restrike free load interruption may not take place. Restrike results in the re-ignition of current flow and is followed by a high voltage and current transient similar to an overshoot experienced during capacitor energization (see NEPSI tech-note on Capacitor Bank Switching Transients at the following web address <http://www.nepsi.com/transients.htm>). The transient however, is far worse and can result in equipment damage as shown and experienced by our equipment in Figure 2.

Figure 2 - Restrike Caused 5 Capacitors to Rupture Like the Opening of a Sardine Can as Shown Above

- After Installation of the vacuum switch within the enclosure, measure the capacitance across each vacuum bottle when the switch is in the open position. A high end, low capacitance meter such as the one shown in figure 7 is required to perform this test. If nearly equal values of capacitance are not measured, install sufficiently sized grading capacitors to equalize the voltage.
- After installation of the grading capacitors, re-check the capacitance across each vacuum bottle to ensure nearly equal values. If values are not nearly equal, adjust the size of the grading capacitor.

After the installation of grading capacitors, the vacuum switches operated free from restrikes during de-energization.

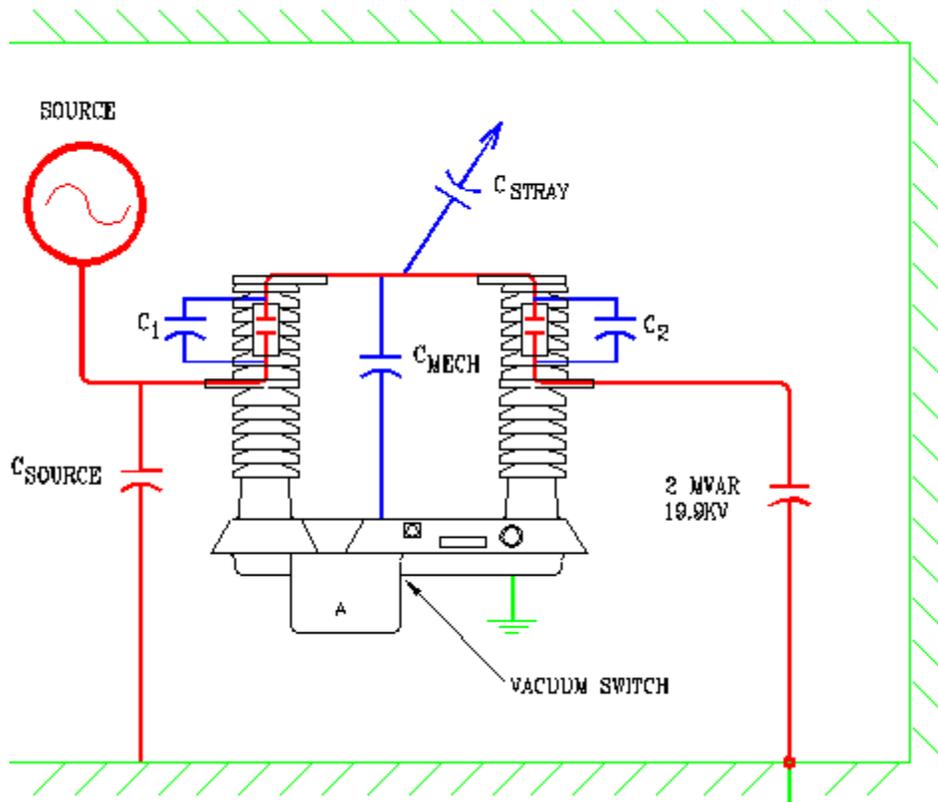
Figure 3 - Capacitor Voltage, Vacuum Bottle Voltage and Line Voltage With $C_{mech} + C_{stray} = 35\text{Pf}$

Figure 3 illustrates the reason restrike is more probable in vacuum switches that utilize two or more series connected vacuum bottles. The figure shows a single-phase representation of a vacuum switch utilizing two series connected vacuum bottles, utility voltage source, 2 MVAR capacitor bank, vacuum bottle capacitance, and capacitance connected to the mid-point of the vacuum bottles. The mid-point capacitance consists of C_{stray} and C_{mech} . C_{mech} exists regardless of whether the bank is mounted in an enclosure or outside on a rack. C_{stray} consists of capacitance to all other grounded objects (in our case, the metal enclosure).

The mid-point capacitance causes unequal voltage division between the two series vacuum bottles during interruption. Ideally, as stated above, equal voltage division between the vacuum bottles is desired. The unequal voltage division causes the line-side vacuum bottle to carry a disproportionate amount of the Transient Recovery Voltage (TRV) during de-energization of the bank. Based on field measurements, nearly 70% of the TRV can be distributed across the line-side vacuum bottle (in a two vacuum bottle switch), while the load side vacuum bottle experiences near 30%. Figure 4 below illustrates how the voltage division is developed during de-energization. In looking at the figure and the equations, and assuming that C_1 equals C_2 , it is obvious that the sum of $C_{mech} + C_{stray}$ causes the unequal voltage division.

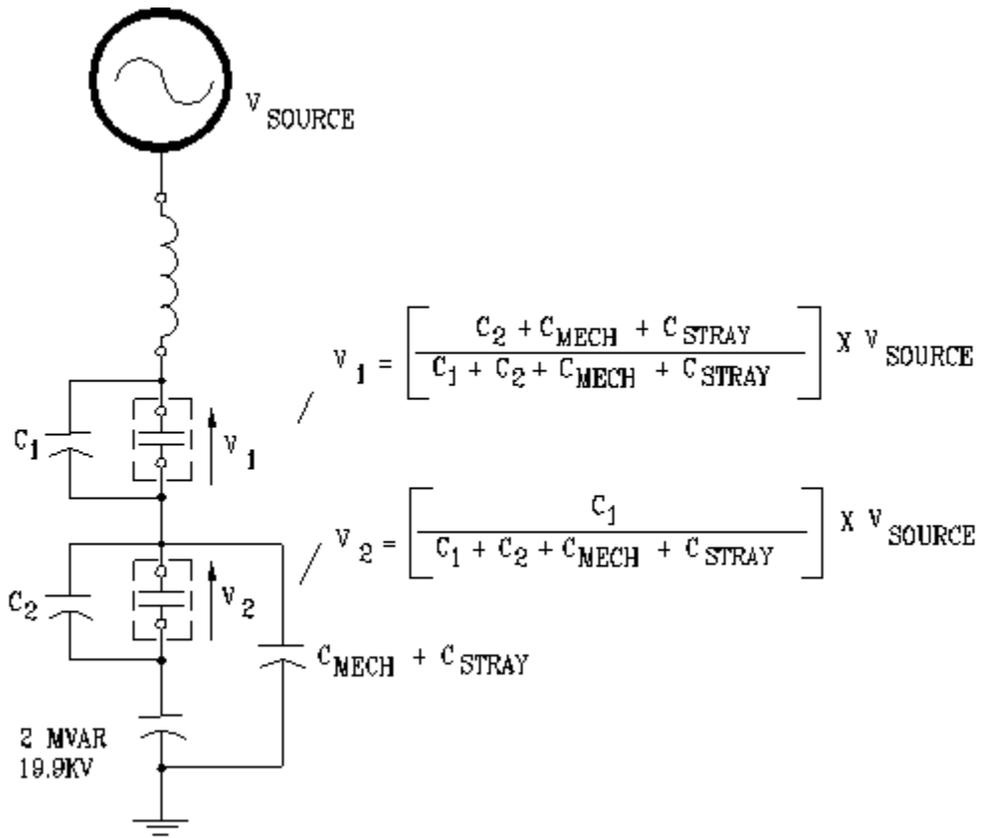
Figure 4 - Capacitor Voltage, Vacuum Bottle Voltage and Line Voltage With $C_{mech} + C_{stray} = 35Pf$

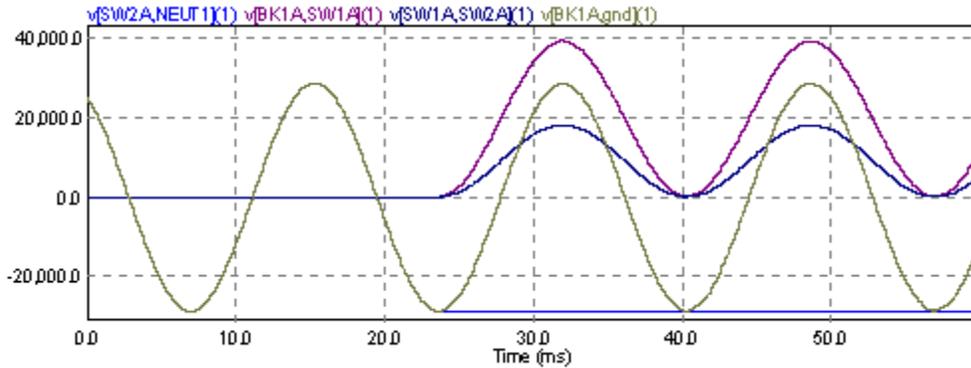
Figure 5 and Figure 6 below show the waveform plots as simulated in EMTP by NEPSI using field test data of the actual system at the City of Burbank. The waveforms show a disproportionate voltage across the line side vacuum bottle. Nearly 70% of the TRV is dropped across the line-side vacuum bottle and only 30% across the load-side vacuum bottle. This unequal sharing resulted in switch restrike.

Figure 5 - Capacitor Voltage, Vacuum Bottle Voltage and Line Voltage With $C_{mech} + C_{stray} = 35\text{Pf}$

- $V[\text{SW2A,NEUT1}](1)$ = Capacitor Voltage to Ground
- $V[\text{BK1A,SW1A}](1)$ = Voltage Across Line-Side Vacuum Bottle during interruption
- $V[\text{SW1A,SW2A}](1)$ = Voltage Across Load-Side Vacuum Bottle during interruption
- $V[\text{BK1A,gnd}](1)$ = System Line-Ground Voltage at Capacitor Bank Terminals

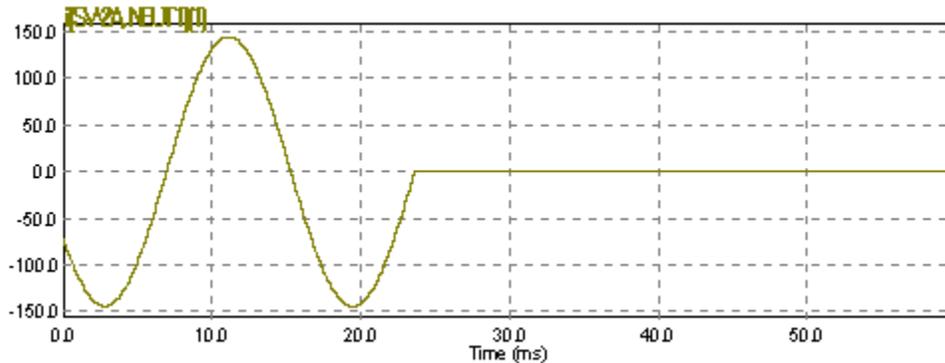
Figure 6 - Capacitor Current With $C_{mech} + C_{stray} = 35\text{Pf}$

- $i[\text{SW2A,NEUT1}](1)$ = Switch current or capacitor bank current

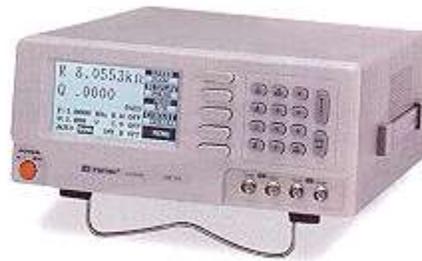
Figure 7 - A High Precision LCR Meter With an Accuracy On The Order of 0.05% in the Picofarad Range is Required to Ensure Equal Capacitance Across the Vacuum Bottles

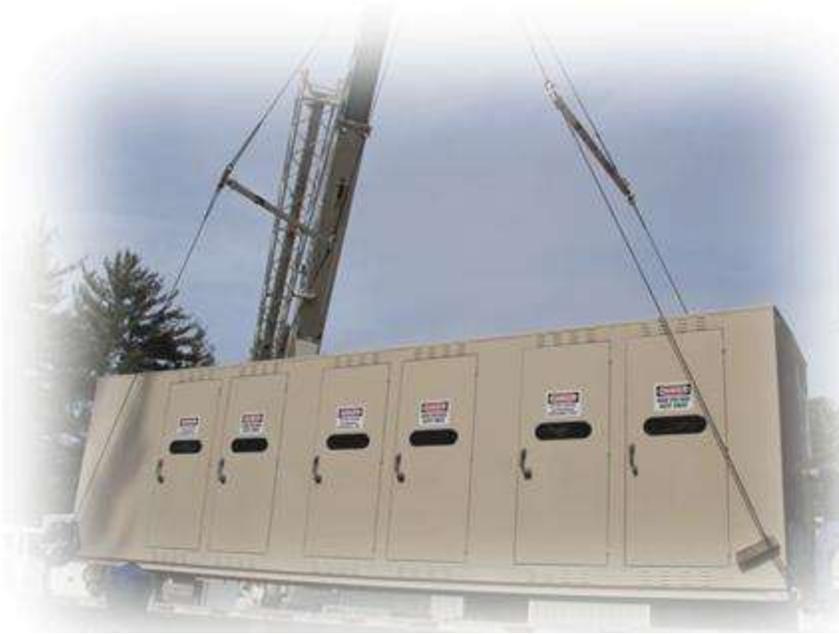
Figure 8 - Picture to left shows the 18 MVAR 3 Step 3 stage automatic capacitor bank being loaded for shipment to the City of Burbank. The bank was of all stainless steel construction and painted per the customer's requested color.
