## Why Bus Bar Connections Should Be Specified

### The interconnection of components with cable in capacitor/harmonic filter banks can lead to bank failure

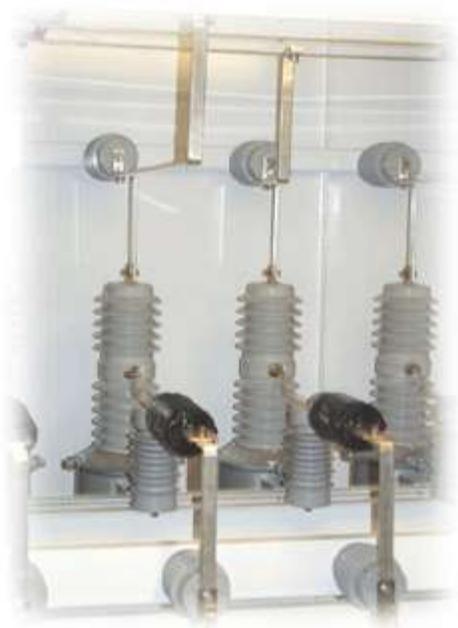
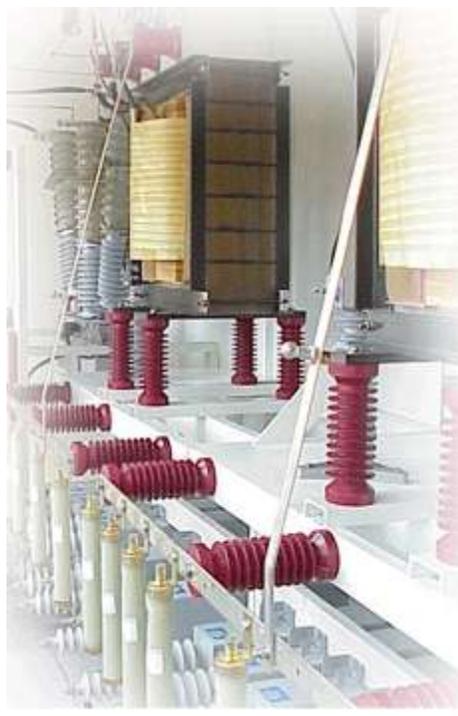
Above two pictures shows how NEPSI interconnects components with Silver or Tin-plated Copper Bus Bar. This method of interconnection is not prone to failures associated with forces during capacitor bank energization. Over the life of the equipment, air provides the best insulation medium as it does not allow for tracking or treeing that is common with solid dielectric cables. See the following link for further information on Phase and Ground Bus System.

During bank energization, current magnitudes can reach well over 10,000 amps. For a typical capacitor bank with components interconnected with cable having a spacing of 3 inches, forces on the order of 144 pounds per foot of cable will be experienced. Over many energization cycles, this force will eventually fail the cable. For this reason, NEPSI's makes every attempt to hard bus all components within our capacitor banks and harmonic filter banks.

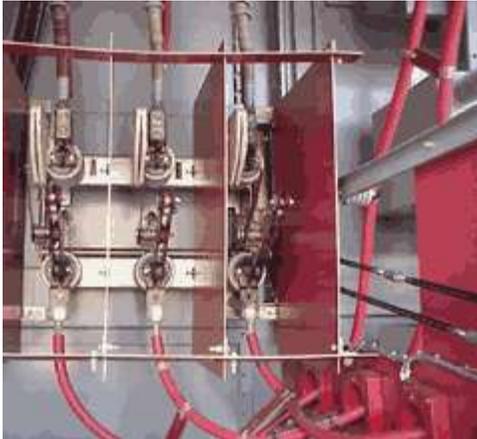
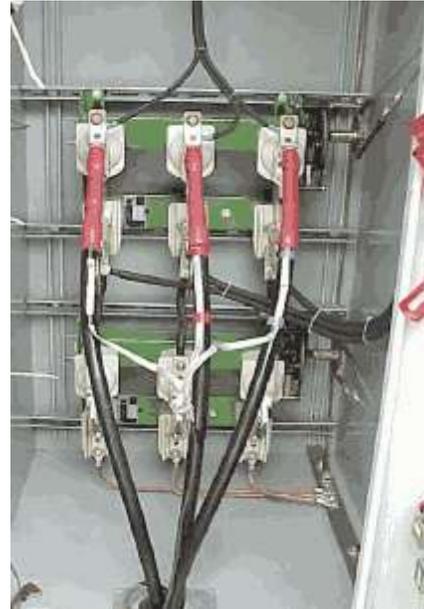
## Two of Our Competitors

The above pictures show a couple of our competitor's incoming compartments and extensive use of "tiger cable" or jumper cable". Note the long runs of cables, and places where cable fatigue can occur. Also note lack of steel barrier between incoming compartment and capacitor compartment and the use of tie wraps to hold current transformer secondary wires. Remember that tie wraps can be expected to fail within one to two years.

In addition to cable fatigue, some manufacturers at the 15kV and above voltage level strap or lay tiger/jumper cable over grounded surfaces or tie wrap them together. As the cable is not shielded, localized dielectric stresses (corona) occur on the surface of the cable. Over time the dielectric stress leads to breakdown and eventual cable faulting. NEPSI's designs and builds capacitor banks with the philosophy that for the life of the equipment, air clearance should be utilized as the insulation medium and not tiger/jumper cable as it is more prone to faulting.
